# **How to Avoid Small Area Stains AND BLEMISHES**

**in the Design, Installation  
and Use of Indiana Limestone**

by  
**W. H. McDonald**

**INDIANA LIMESTONE INSTITUTE  
OF AMERICA, INC.**

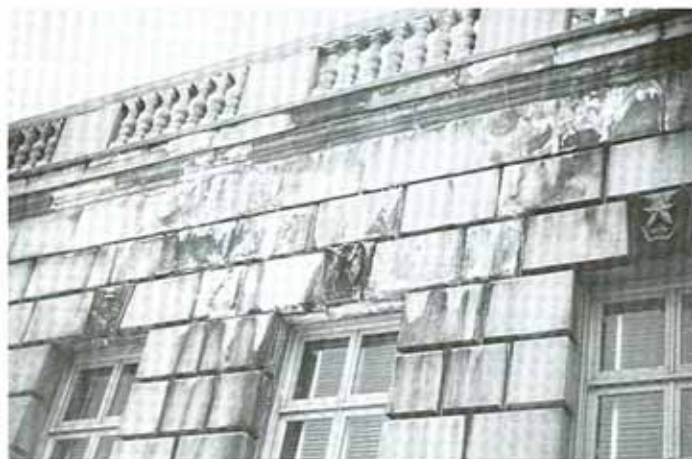
*A badly leaking roof caused this eyesore. When the leaks were repaired, the efflorescence cleared up within a few months.*

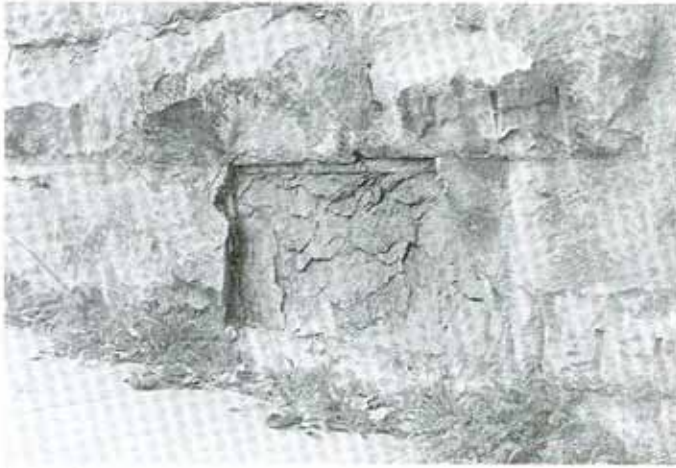
*Typical sheeting in exfoliating limestone at the base course of a retaining wall (ca. 1880). The stone is sluffed off in thin layers. Compare to exfoliation in concrete shown in the following photograph.*

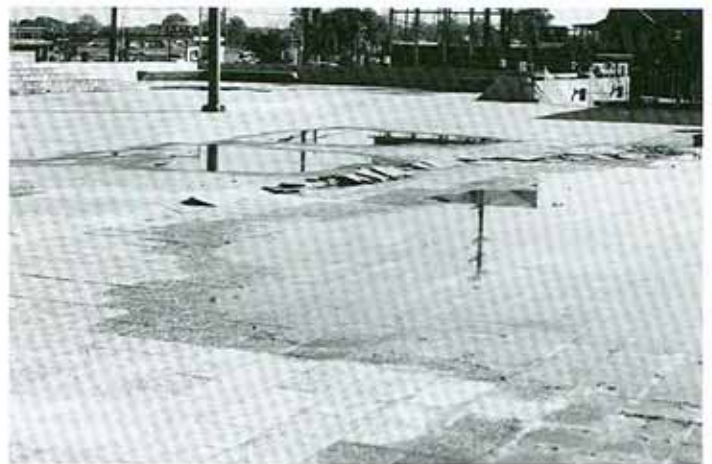
*Improperly designed or constructed decks produce conditions leading to stain, efflorescence and exfoliation in any fascia material at their perimeters. In such extreme situations, damp-proofing as discussed in the text may fail, and physical isolation of the lower fascia from resultant leaks will be the only way to avoid problems.*

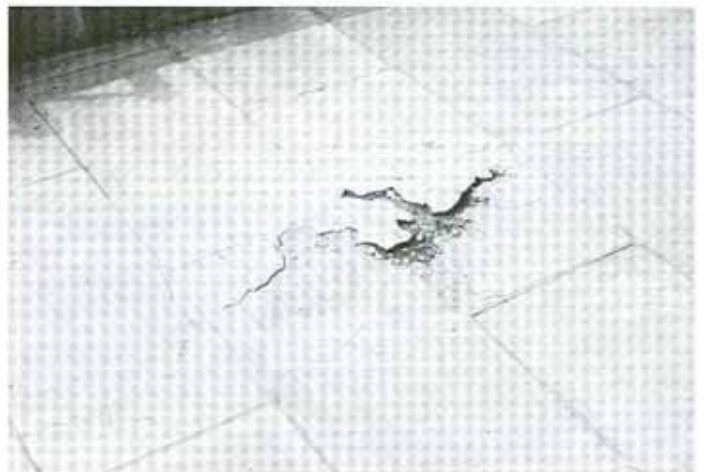
*Over relatively few years, a snow-removal program using salt produced this deterioration on walkway paving.*

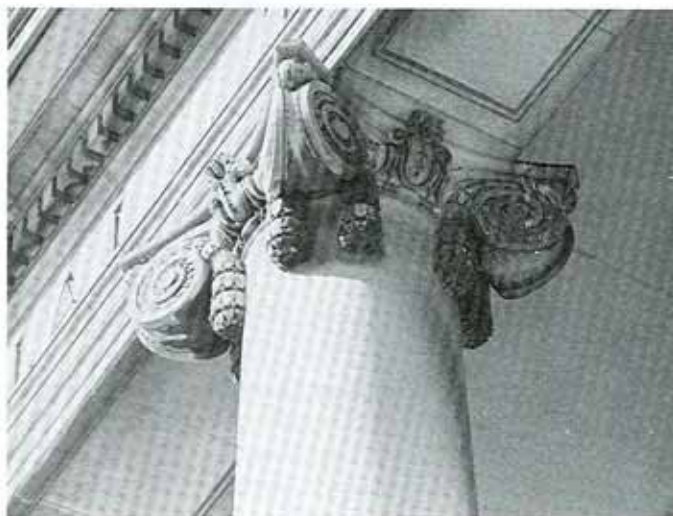
*The lower areas of the volutes on this Ionic cap are protected from weathering. The resultant encrustation from years of soot could be greatly lightened if not entirely removed by scrubbing.*

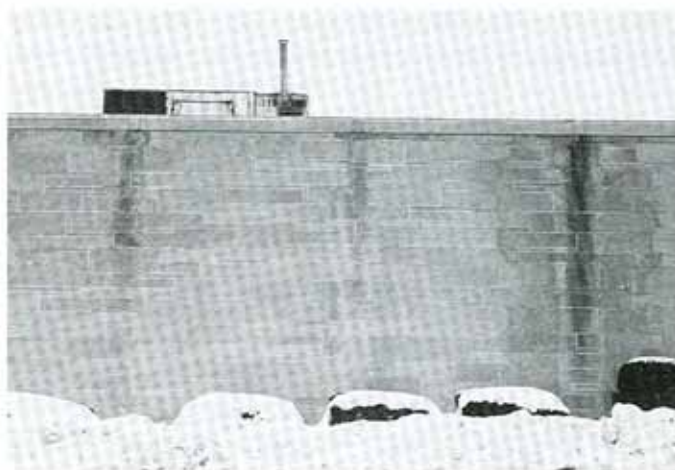
*Leaking connections in this metal coping collect water and dirt which flood over the stone below in a concentrated flow.*

One prevalent condition producing drip tracings occurs where joints in aluminum or other metal coping and gravel-stop are poorly made, or where their surfaces are unsloped. Water pooling in such areas collects dirt, and

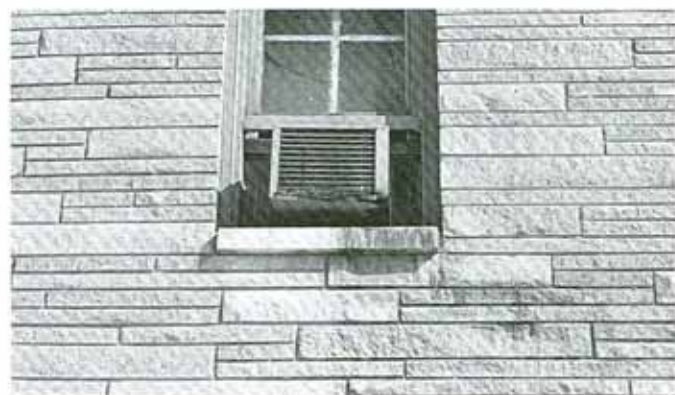
*Lack of maintenance on this air conditioner has produced a badly stained sill and other stones in the splitface wall below.*

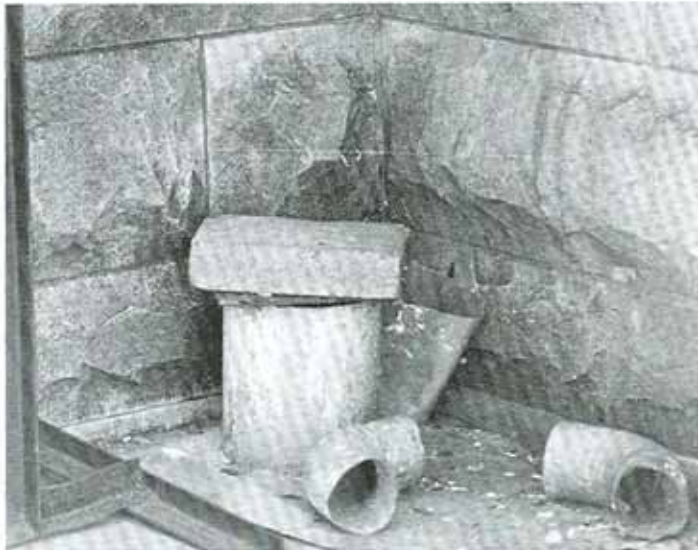
*This corner area provides the necessary conditions for a growth of moss. Other vegetable growth may develop with the added nutrients of droppings.*
